# Building Inspection Report

**37201 E. 31st Street, Tucson, AZ 85710**

03/20/06

**PJM  
Home Inspections, LLC.**

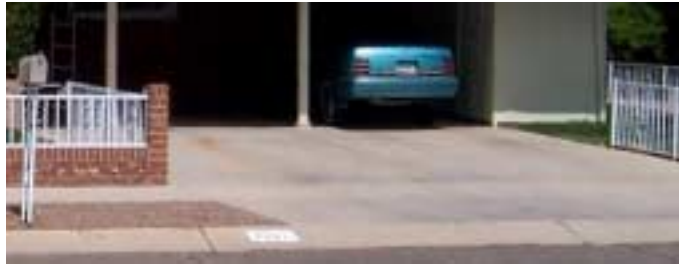
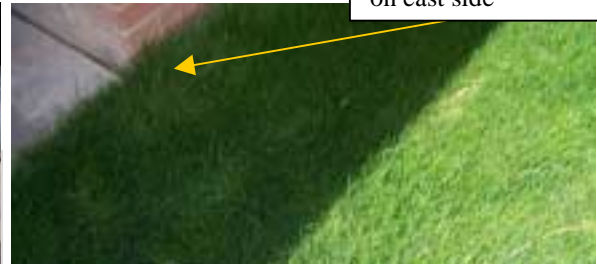
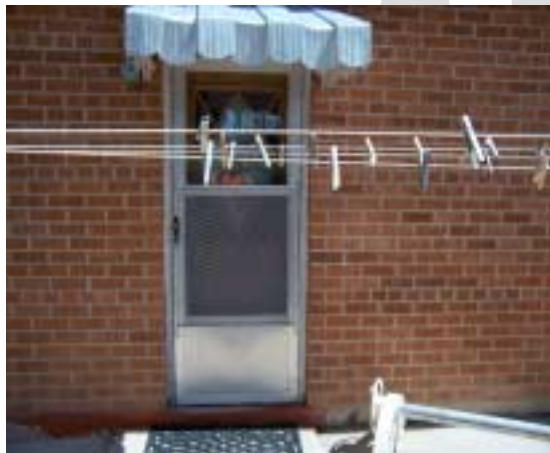
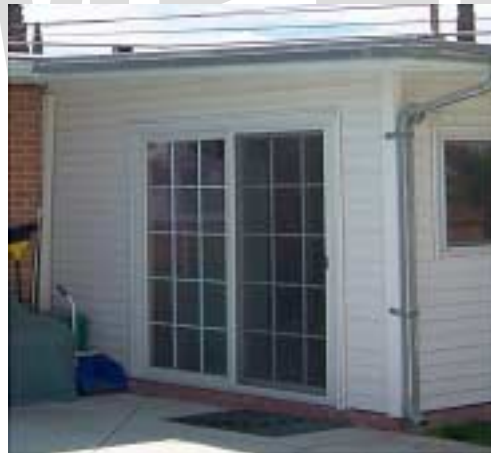
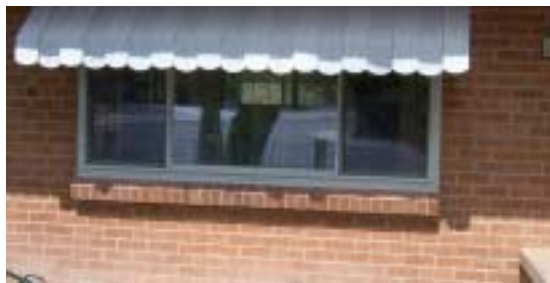
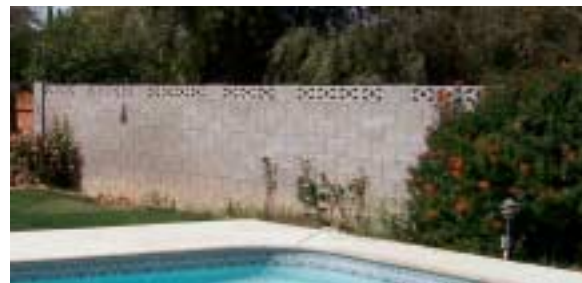
Grade towards house on east side

- **Improve, Repair:** The grading should be improved to promote the flow of storm water away from the house. This can often be accomplished by the addition of top soil. The ground should slope away from the house at a rate of one inch per foot for at least the first ten feet. At least eight (8) inches of clearance should be maintained between soil level and the bottom of exterior wall siding.

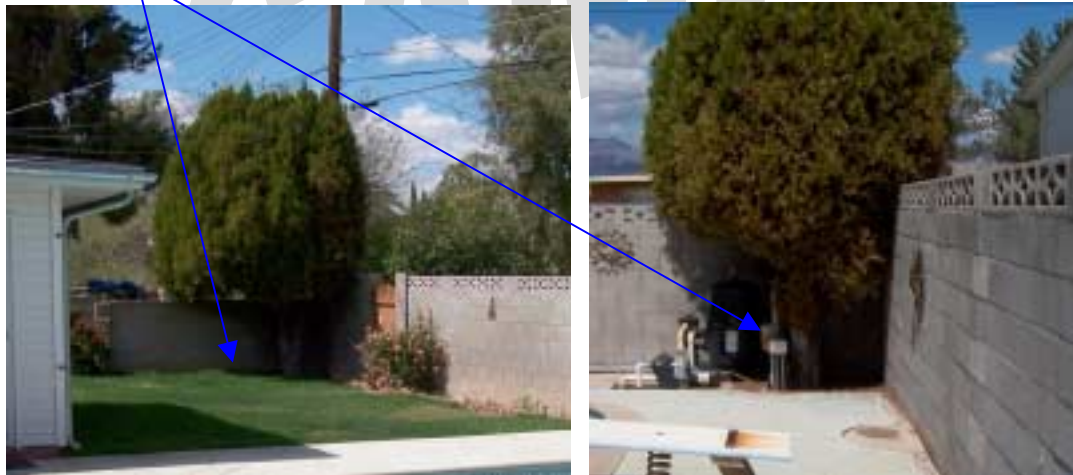
- **Repair:** The proximity of the trees could disrupt drainage pipes, cause mechanical damage to the footings of the masonry wall, or influence the foundation over time. You should consider removal of the trees.

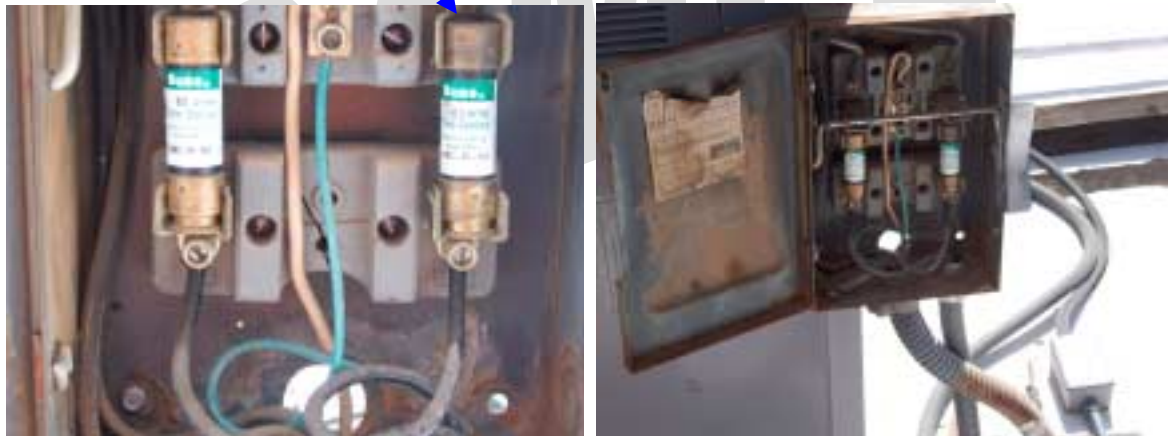
Double taps on "Line" side of protection

- **Repair:** Circuits within the auxiliary panel that are doubled up (referred to as “double taps”) should be separated. Each circuit should be served by a separate fuse or breaker. In this case the double taps occur on the “Line” side of the circuit.

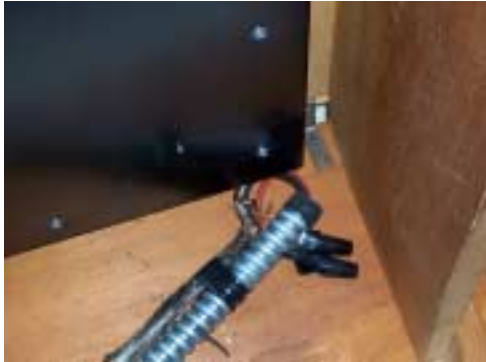
In the kitchen the wiring under the electric cook top is a potential hazard. We recommend the electrical connection be replaced with a terminal block style connection.
