# Building Inspection Report

**37201 E. 31st Street, Tucson, AZ 85710**

03/20/06

**PJM  
Home Inspections, LLC.**

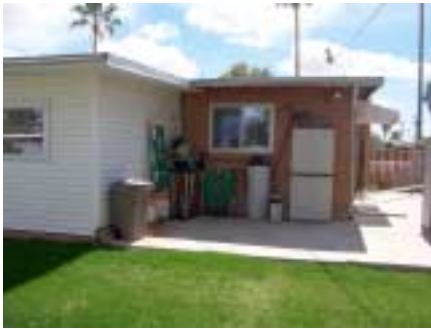
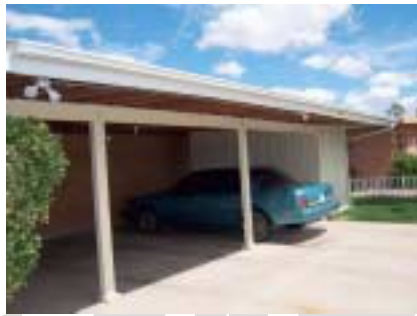
- **Monitor:** Common minor settlement cracks were observed in the foundation walls. This implies that some structural movement of the building has occurred. Cracks of this type should be watched for any sign of additional movement. In the absence of any sign of ongoing movement, repair should not be necessary.

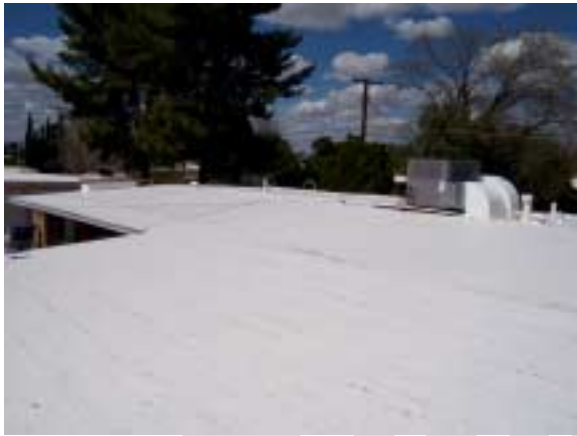
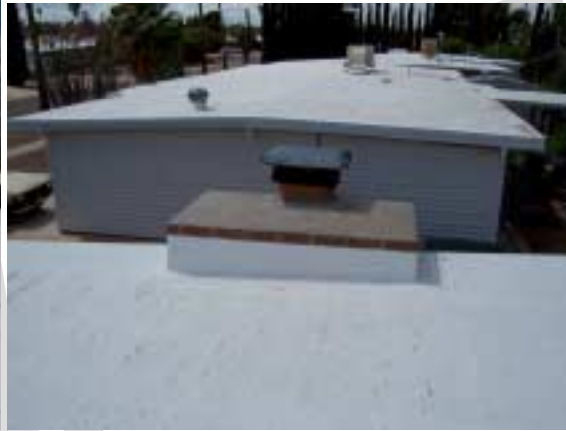
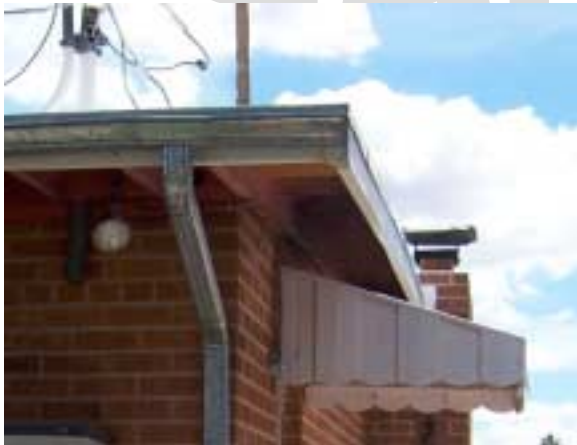
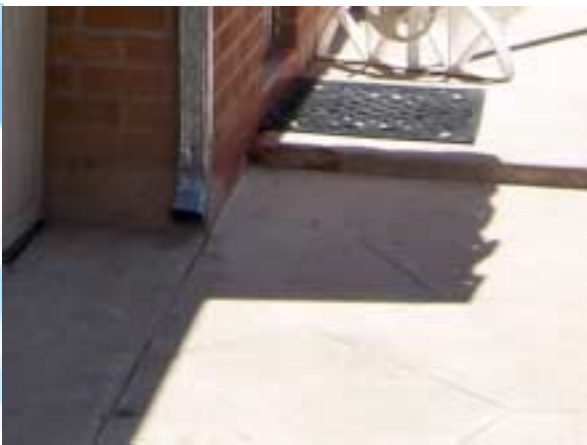
The roof coverings are to be in generally good condition. Roof flashing details appear to be in good order. The chimneys do not show signs of significant deterioration.

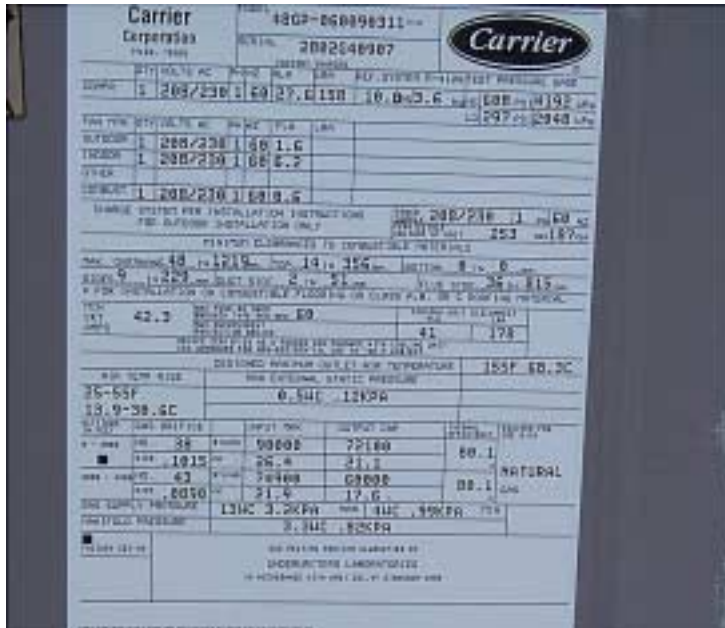
•Air Cooled Central Air Conditioning •Manufacturer: Carrier  
 •Model Number: 48GP-060090311  
 •Serial Number: 2802G40907
